# Run Summary

American Eagle Paper Mill, Tyrone, PA

PM # 3

VenPap

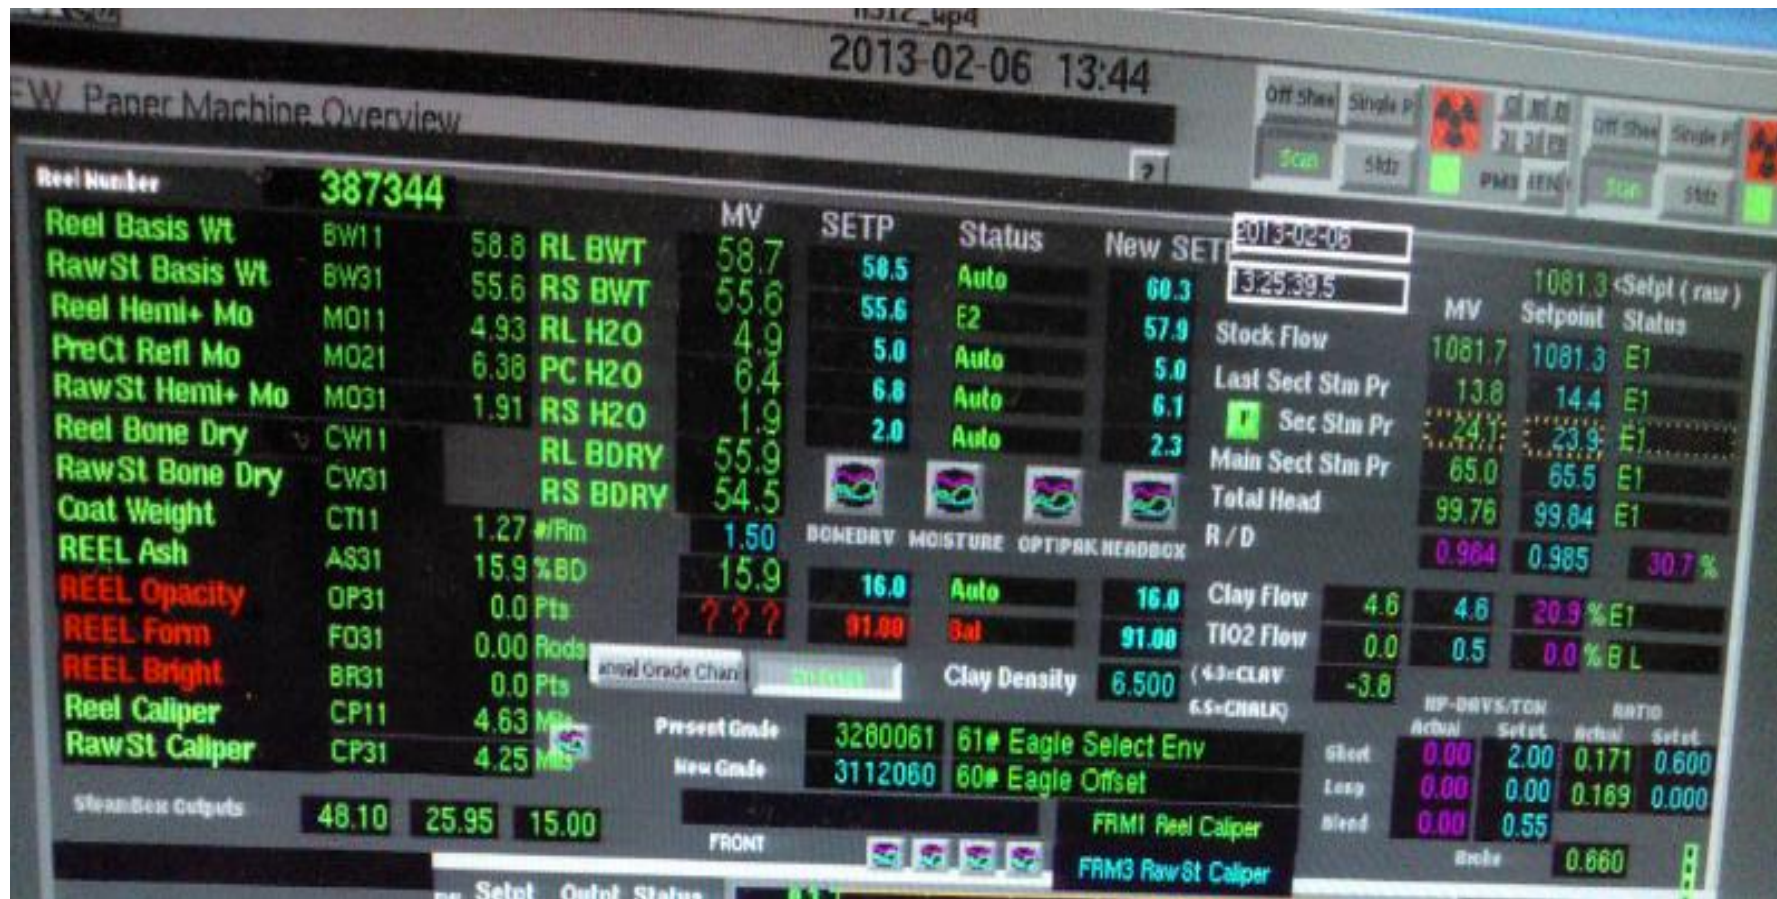
Time taken: 13:44

Main Section Steam Pressure: 65 PSI

VenPap System **NOT** running, vacuum pump running.

Visible: High Main Section Steam Pressure.

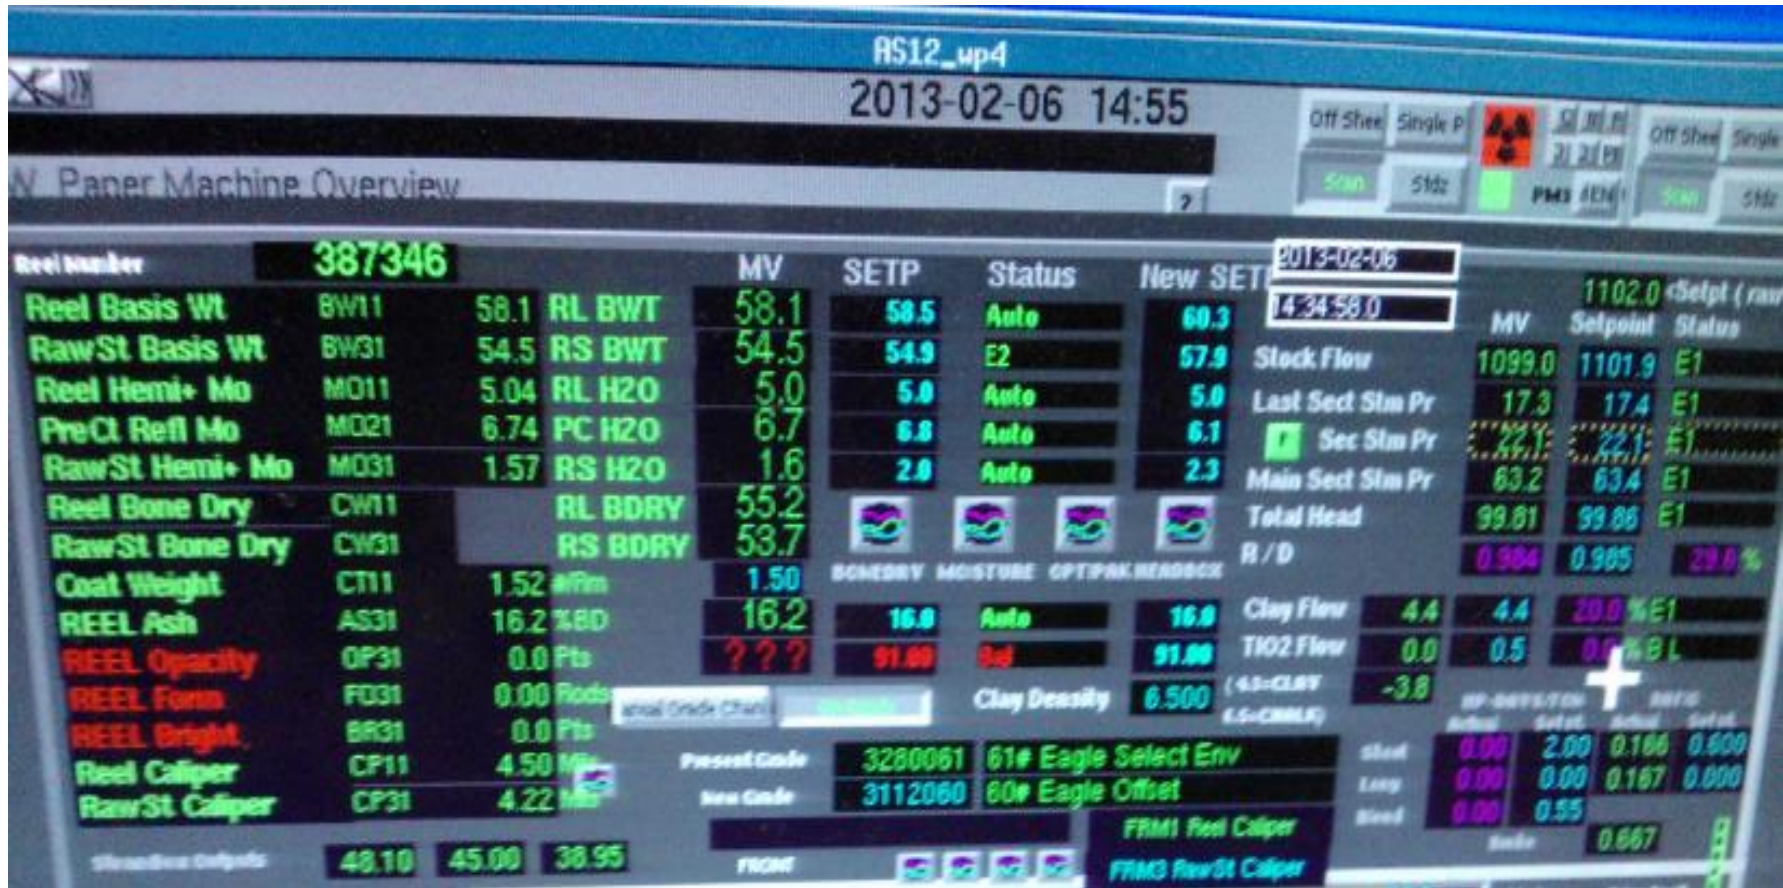
Time taken: 14:55

One hour and 10 minutes after start of Venpap System.

Main Section Steam Pressure: 63.2 PSI, Raw Moisture: 1.6 %.

VenPap System running, valve to the vacuum pump closed, vacuum pump shut down

Visible: Steam pressure and moisture are dropping.

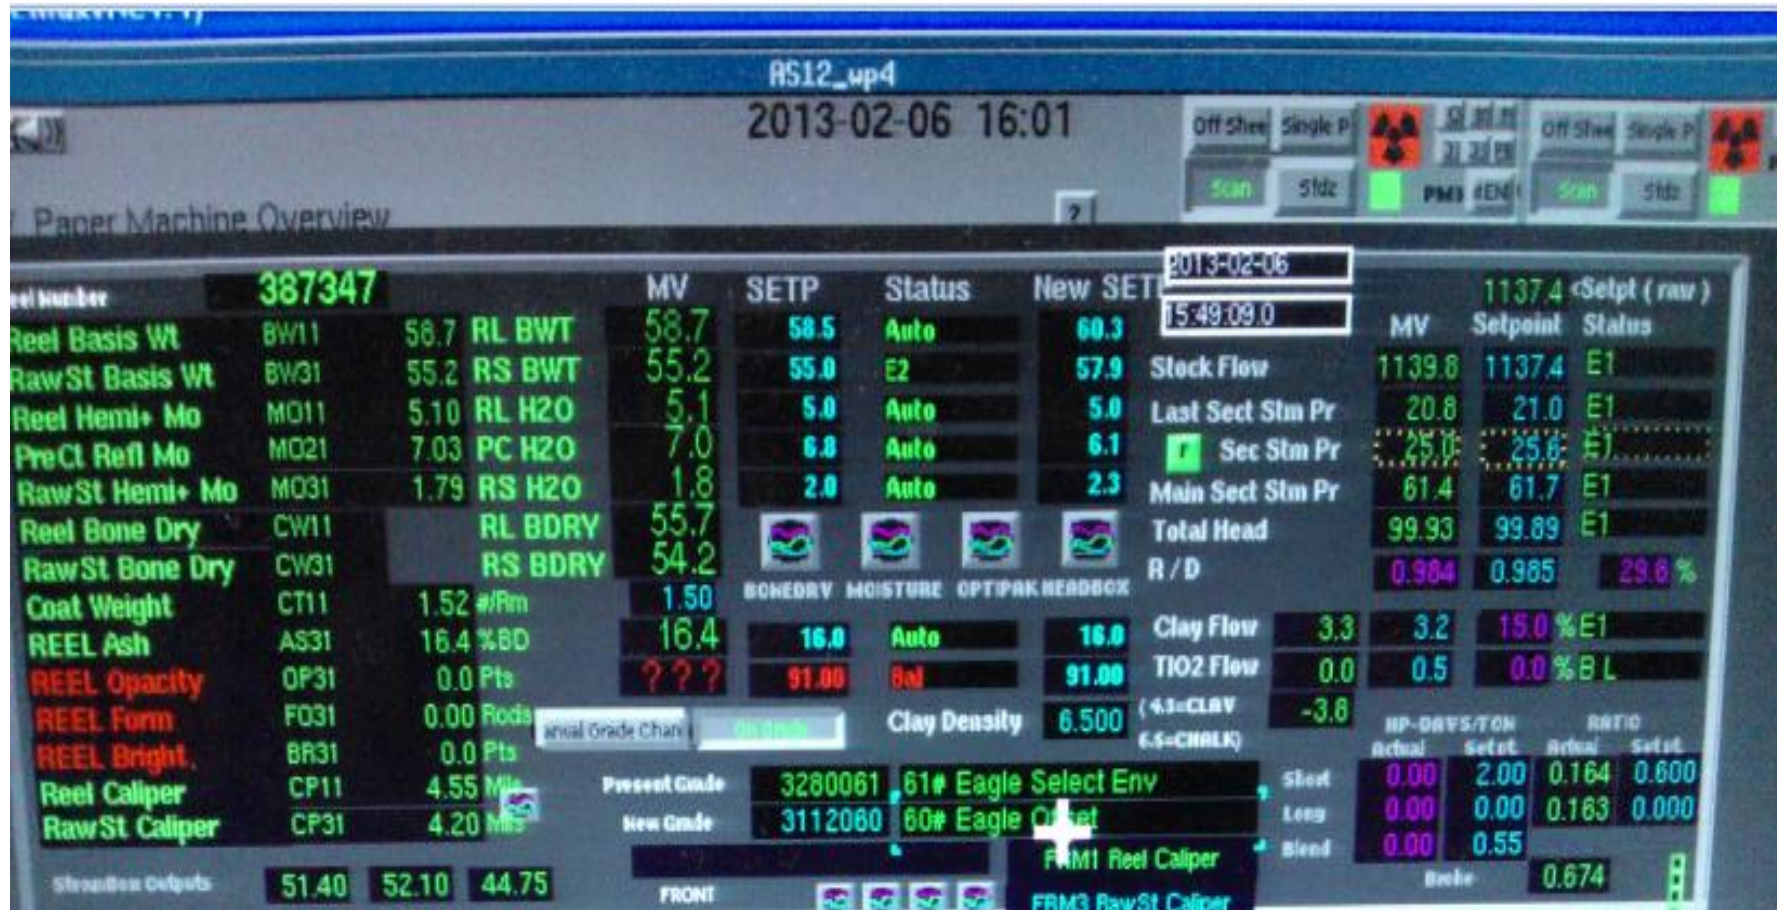
Time taken: 16:01

2 hours and 16 minutes after start of Venpap System.

Main Section Steam Pressure: 61.4 PSI, Raw Moisture: 1.8 % (set point 2.0).

VenPap System running, valve to the vacuum pump closed, vacuum pump shut down

Visible: Steam pressure and moisture are dropping.

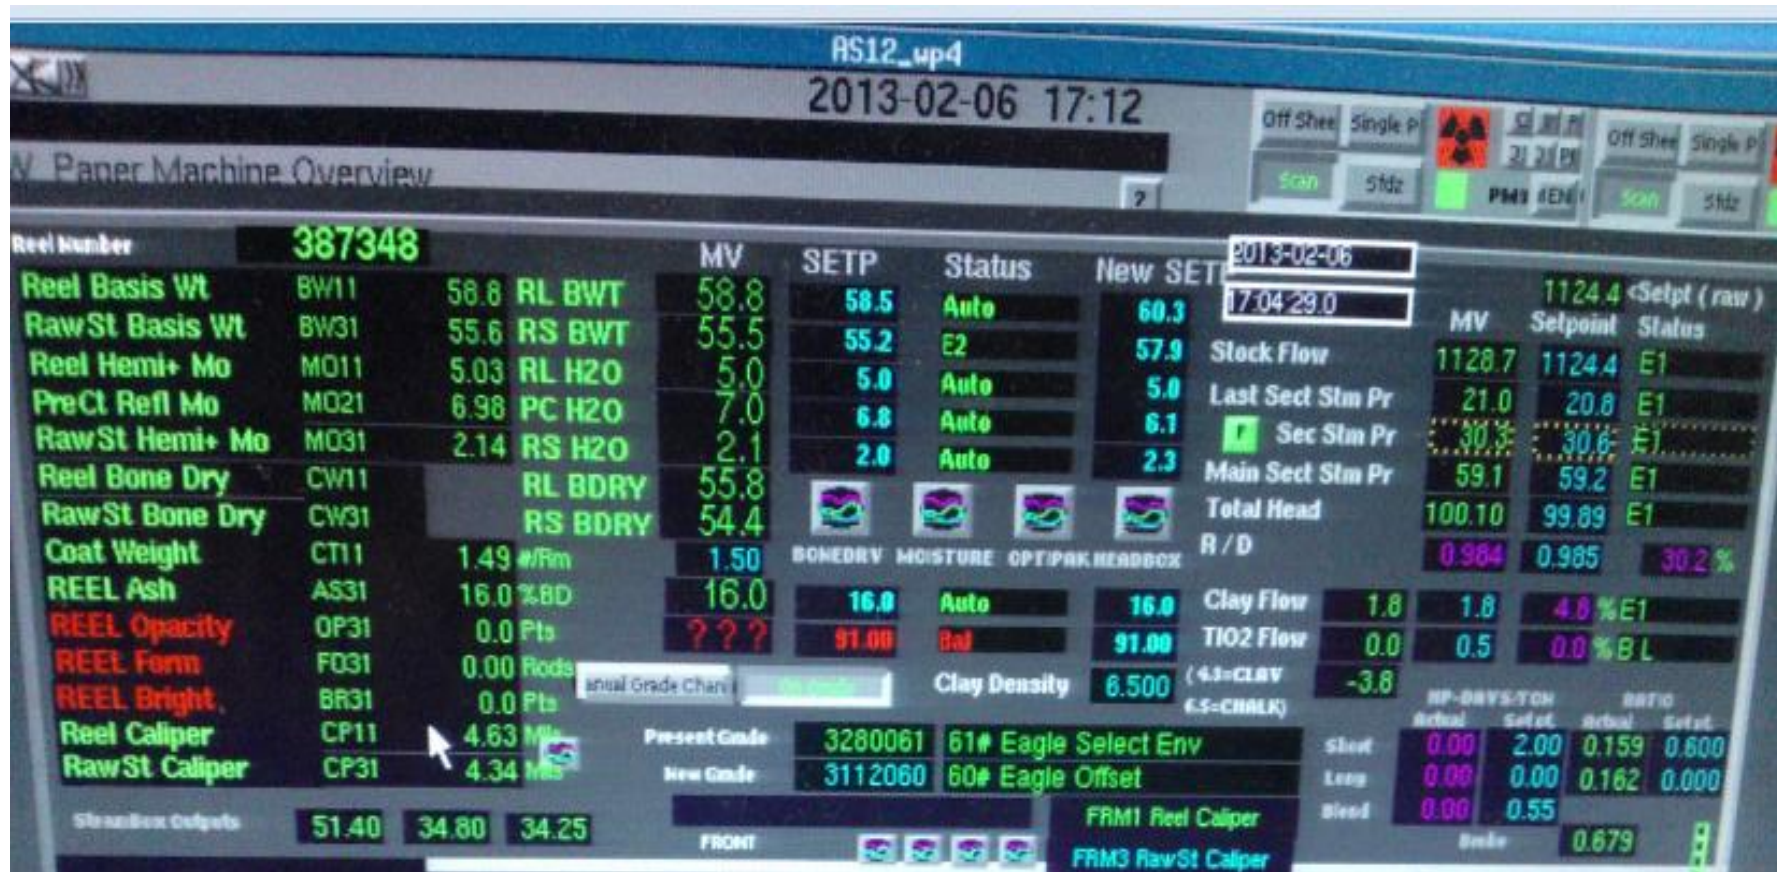
Time taken: 17:12

3 hours and 27 minutes after start of Venpap System.

Main Section Steam Pressure: 59.1PSI.

VenPap System running, valve to the vacuum pump closed, vacuum pump shut down

Visible: Steam pressure dropping.

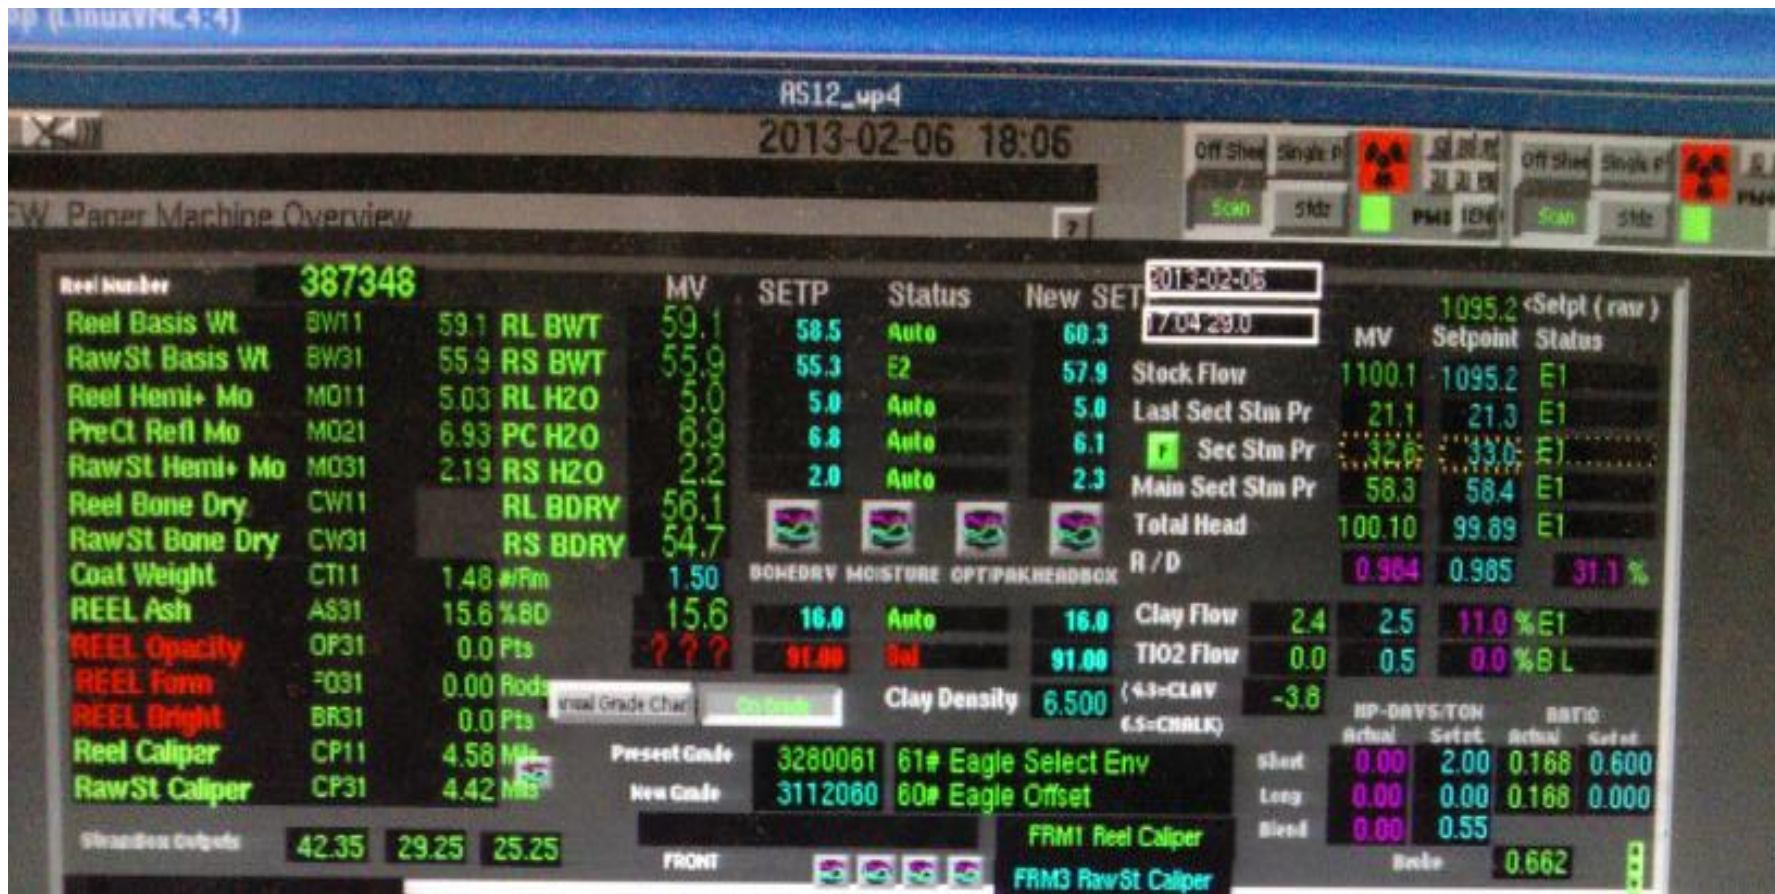
Time taken: 18:06

4 hours and 21 minutes after start of Venpap System.

Main Section Steam Pressure: 58.3PSI

VenPap System running, valve to the vacuum pump closed, vacuum pump shut down

Visible: Steam pressure still dropping.

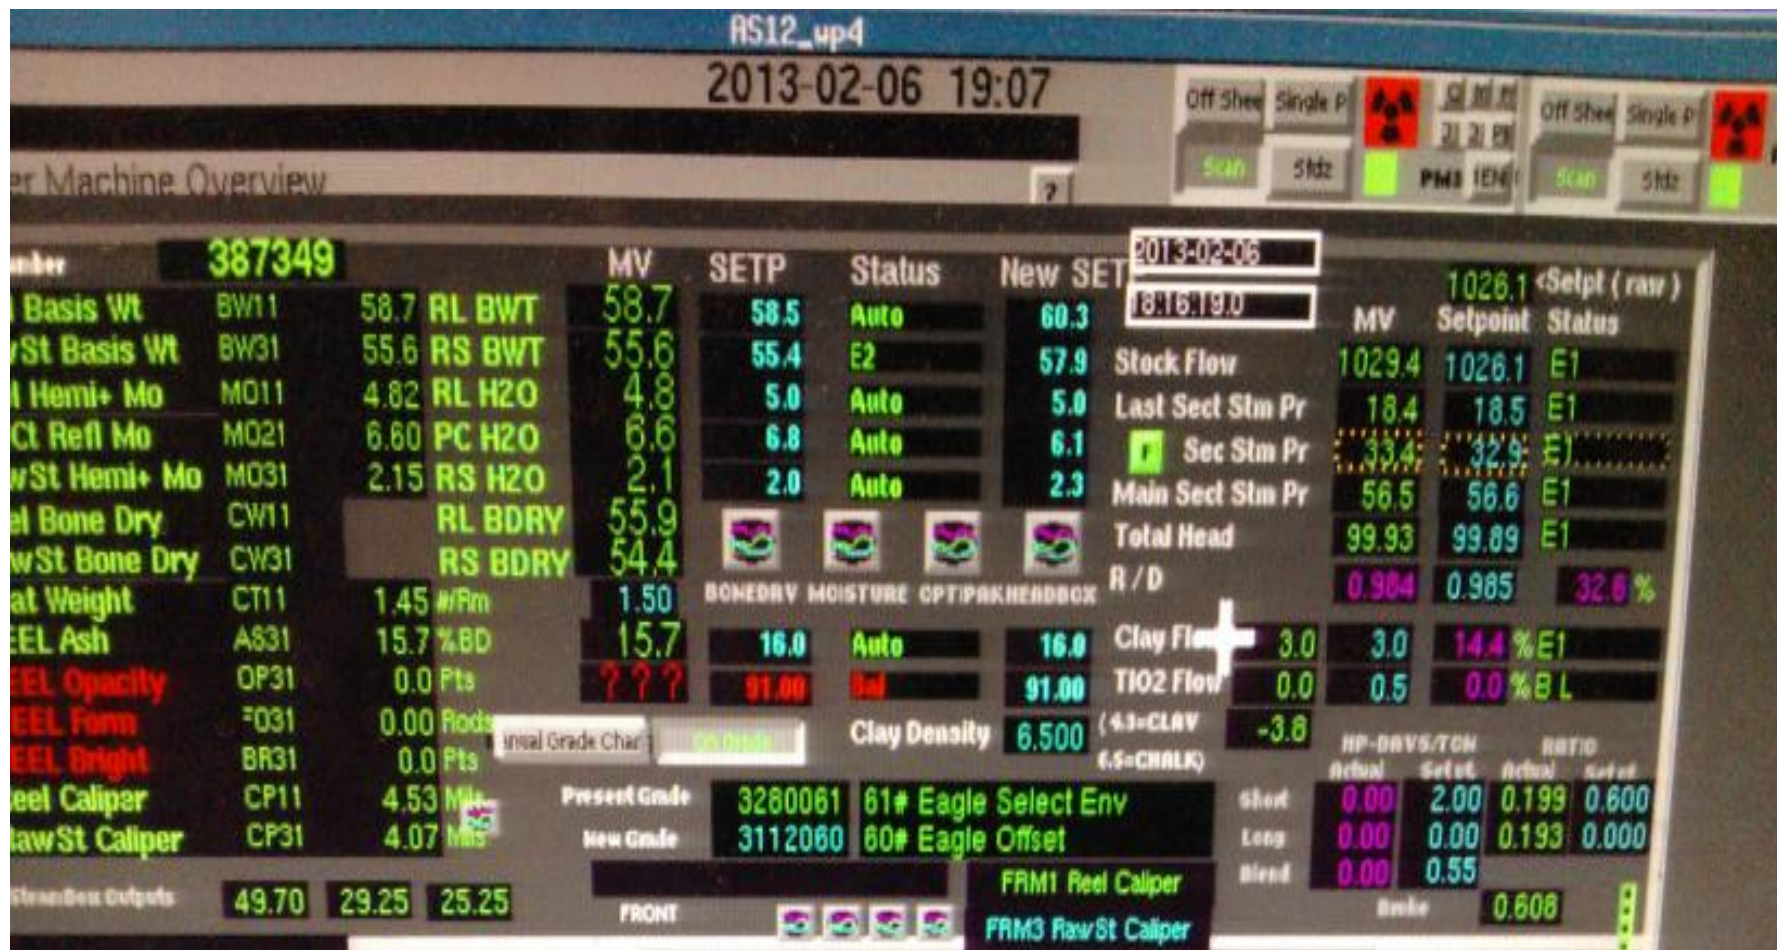
Time taken: 19:07

5 hours and 22 minutes after start of Venpap System.

Main Section Steam Pressure: **56.5PSI**

**VenPap System running, valve to the vacuum pump closed, vacuum pump shut down**

Visible: Pressure to the main steam section decreasing.
